Technical Note N-830

AIRFIELD PAVEMENT EVALUATION - USNAF CHINA LAKE, CALIFORNIA,

R. J. Lowe and W. H. Chamberlin,

July 1966

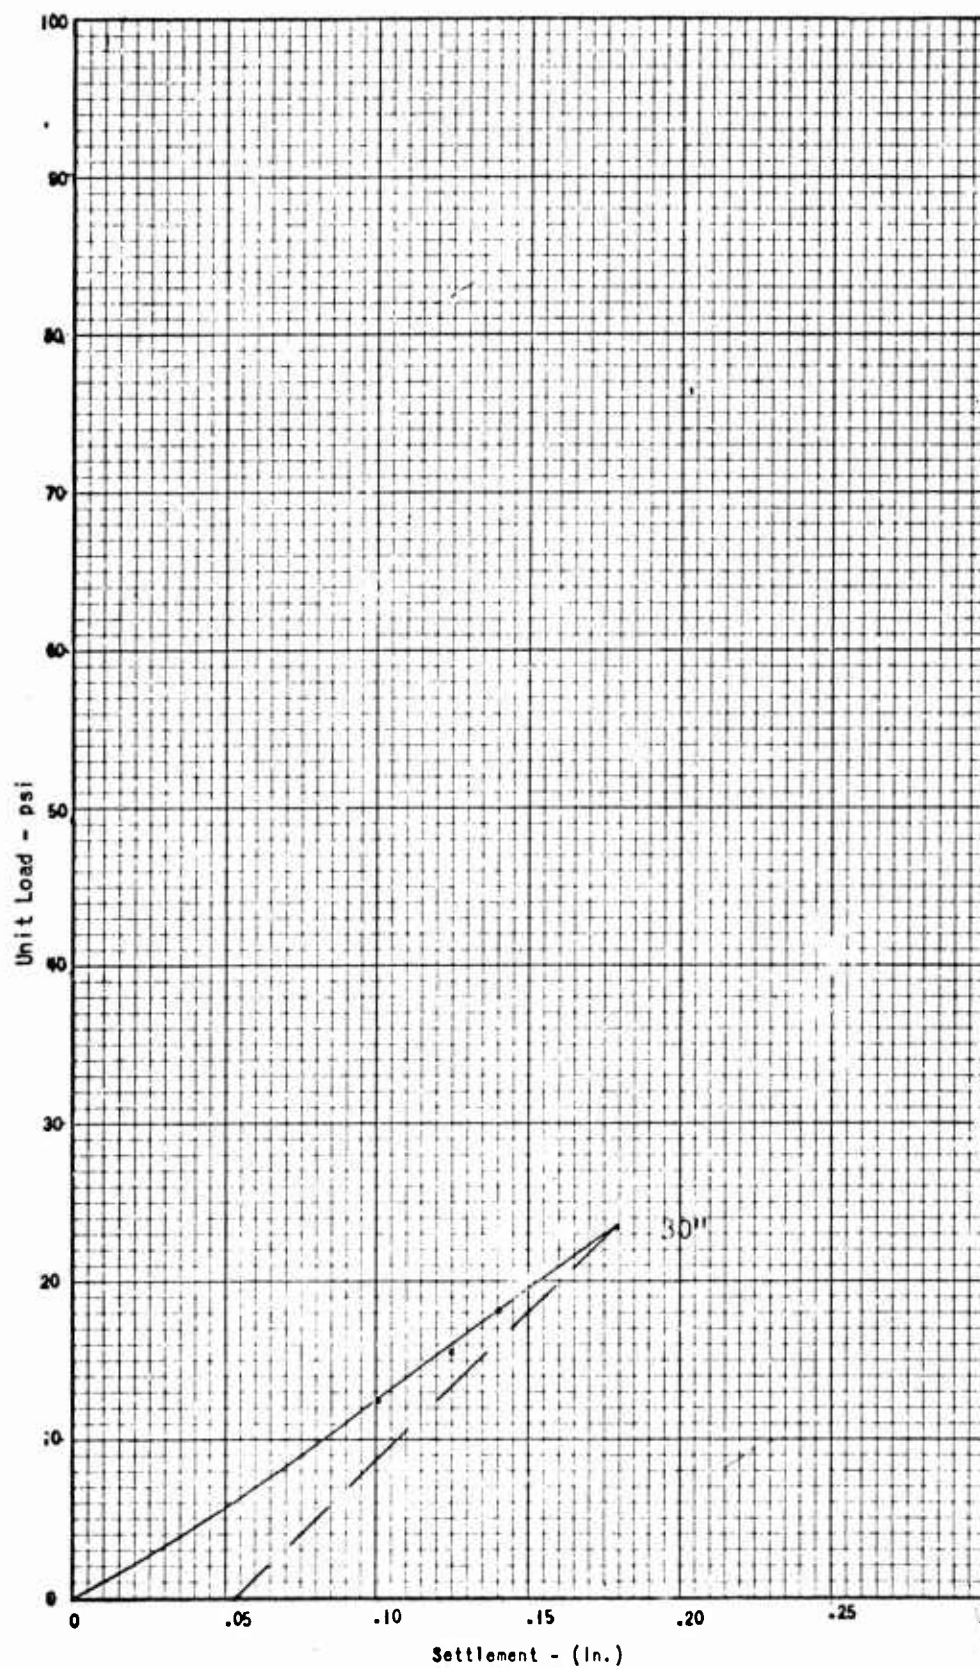
FACILITY	LOCATION	STATION
USNAF China Lake, California	Taxiway 14-32	10+00

13" below top  
of asphaltic  
concrete

$K = 116 \text{ pci}$

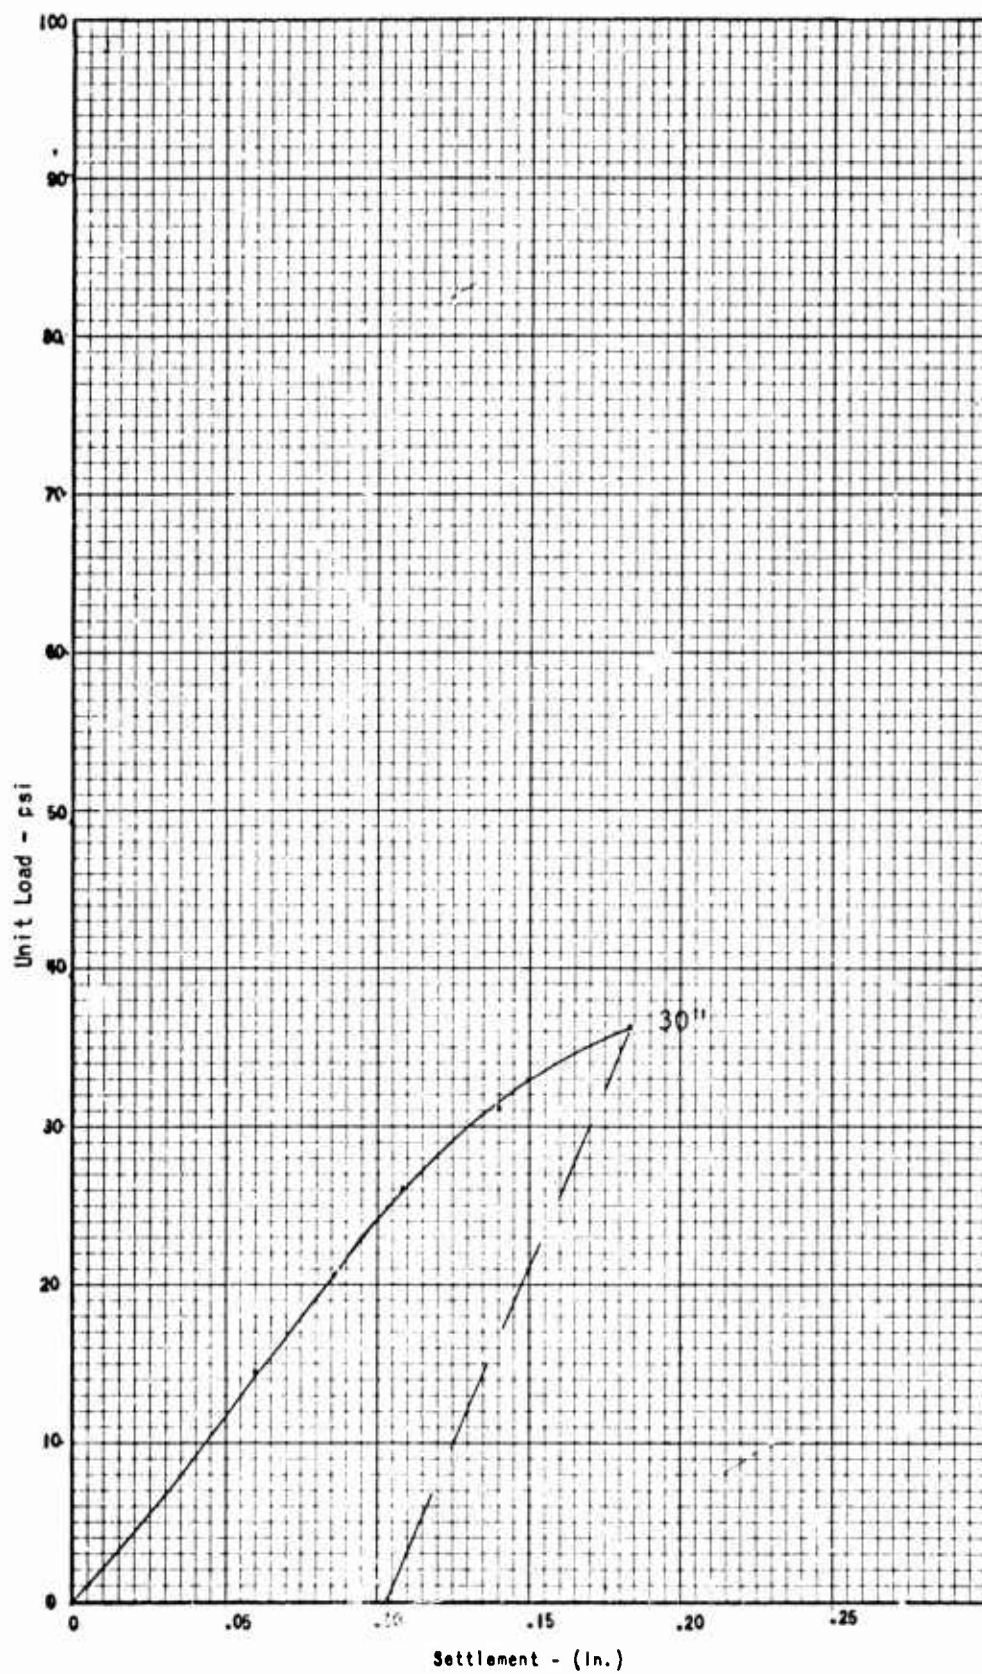
FACILITY	LOCATION	STATION
USNAF China Lake, California	Taxiway 14-32	40+00

15" below top  
of asphaltic  
concrete

$K = 236 \text{ pci}$

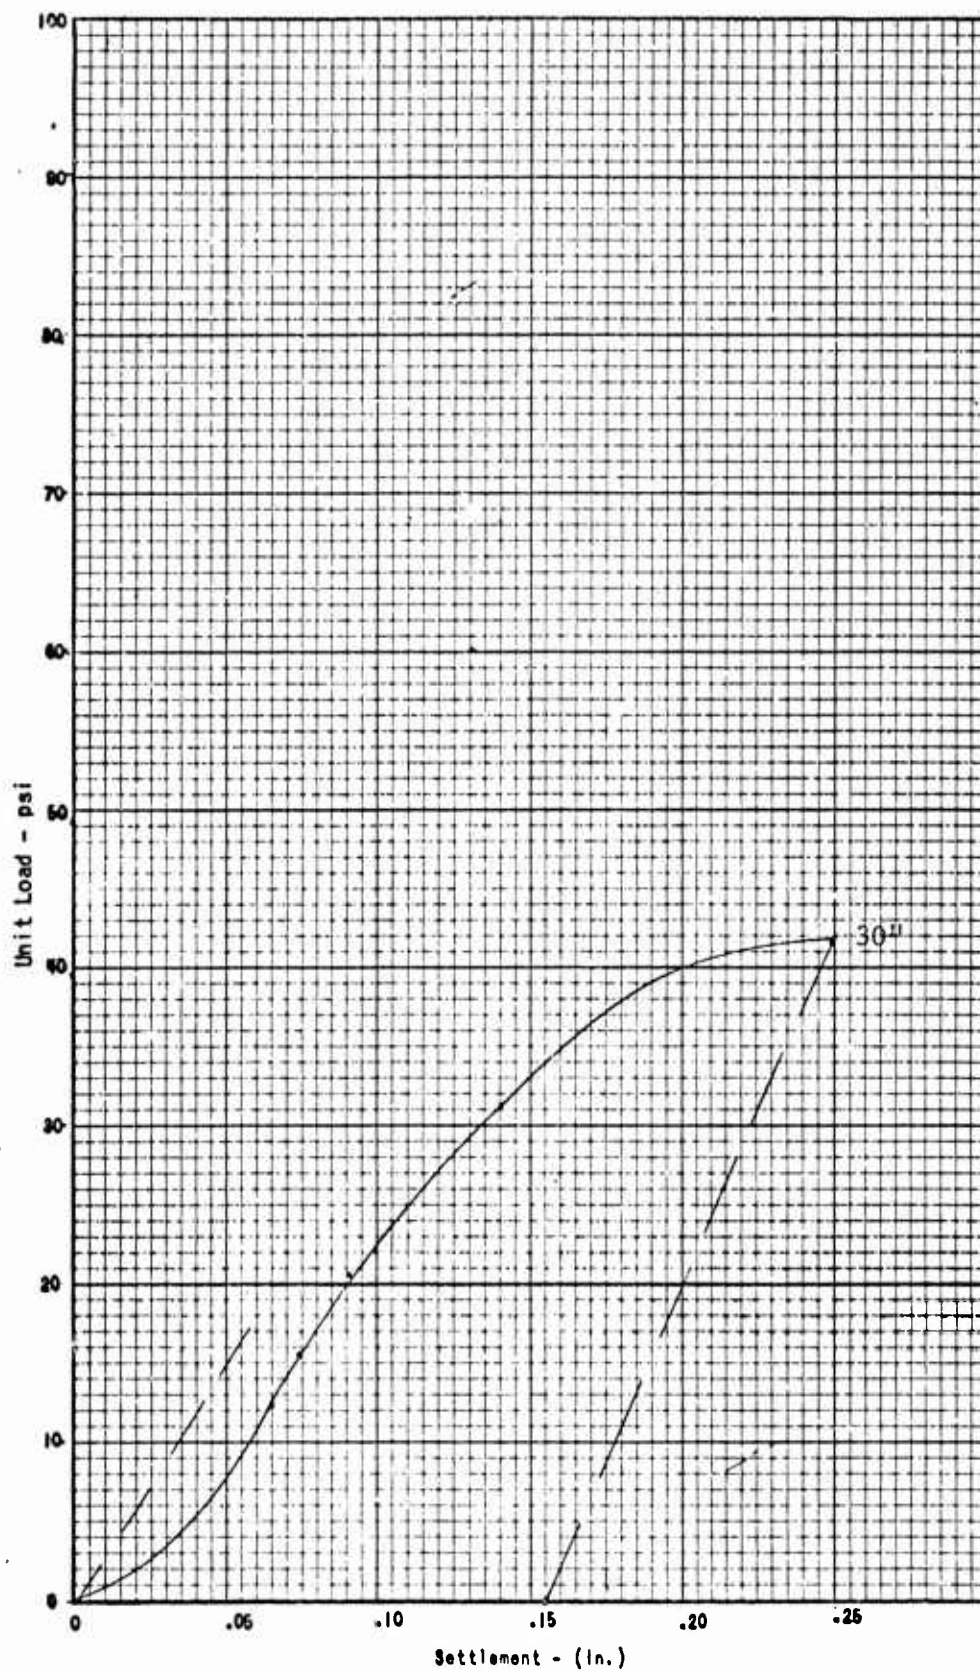
FACILITY	LOCATION	STATION
USNAF China Lake, California	Taxiway 14-32	60+00

K = 298 pci

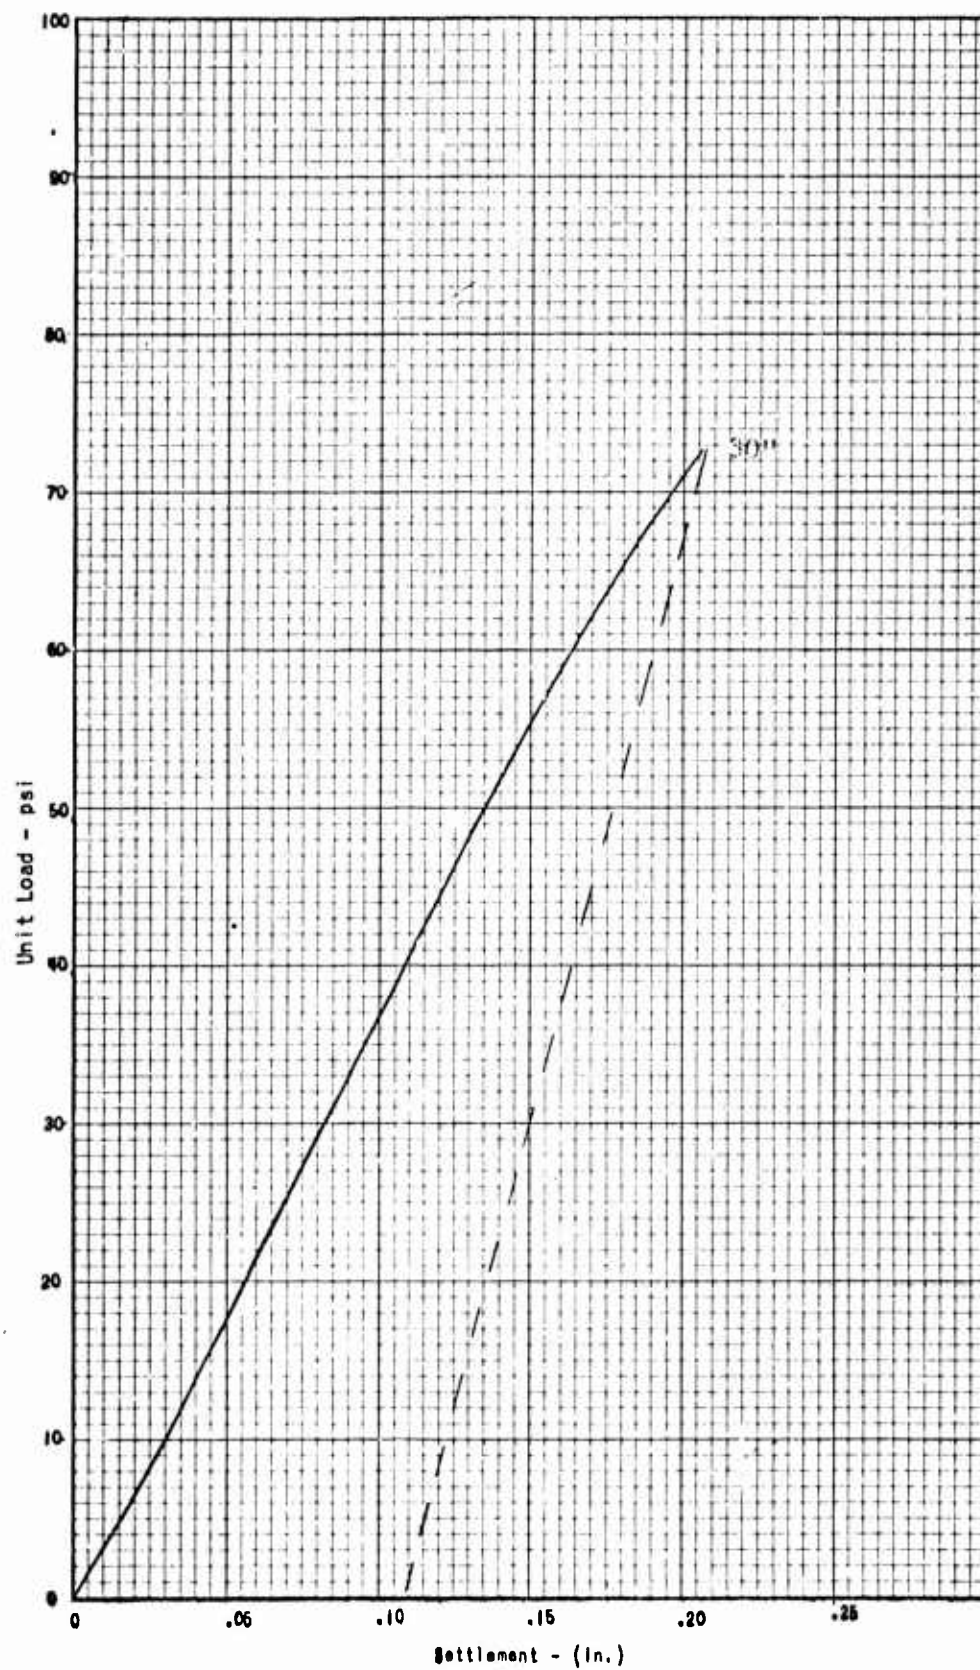
FACILITY	LOCATION	STATION
USNA, China Lake, California	Taxiway 3	2+00

10-1/2" below top  
of portland cement  
concrete

$K = 554 \text{ pci}$

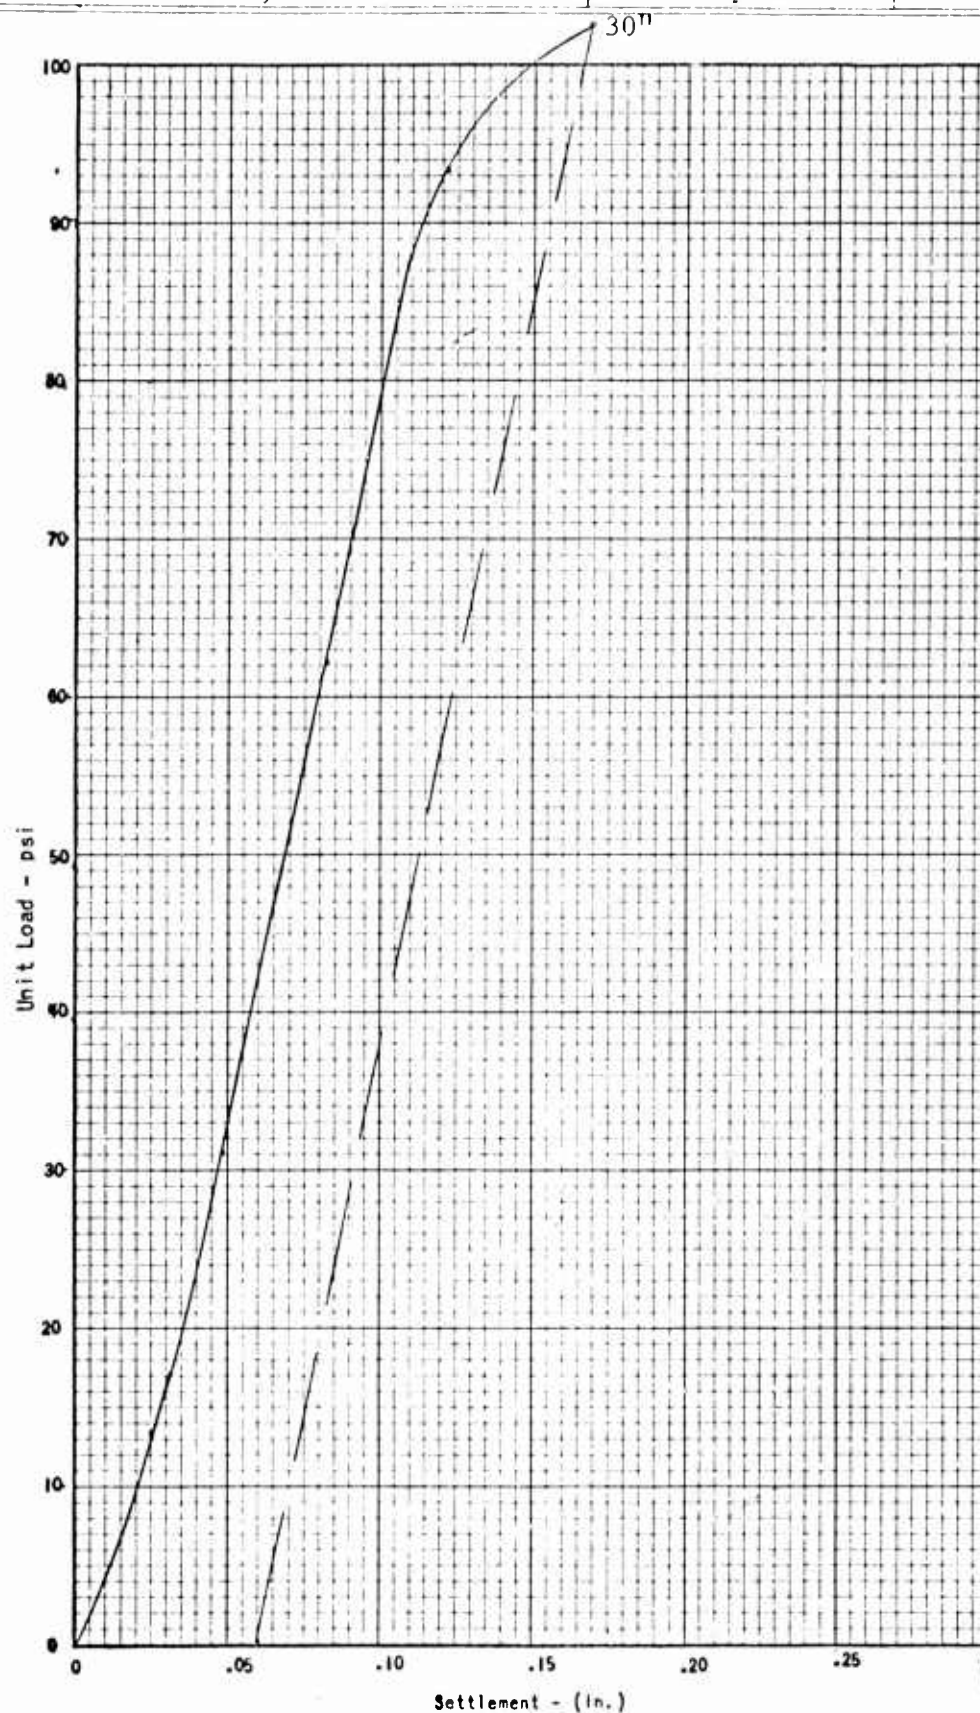
FACILITY	LOCATION	STATION
USNAF China Lake, California	Taxiway 3	24+00

$K = 660 \text{ pci}$

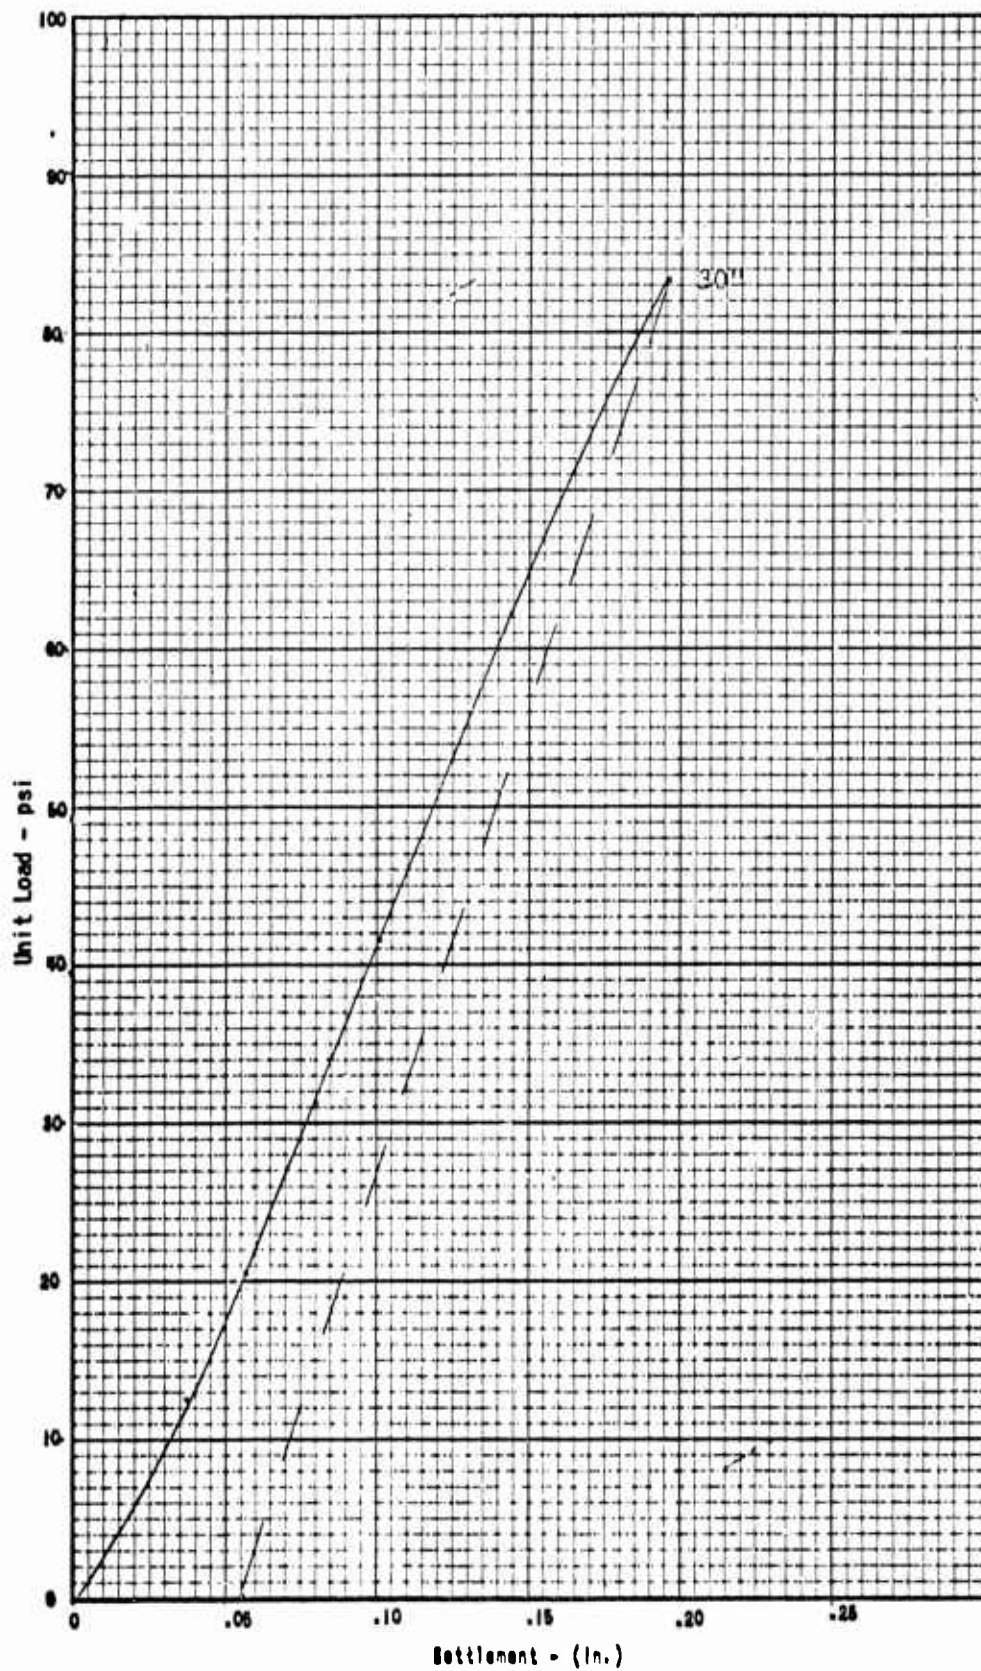
FACILITY	LOCATION	STATION
USNAF China Lake, California	Parking Apron 1	A

9-1/2" below top  
of portland cement  
concrete

K = 352 pci

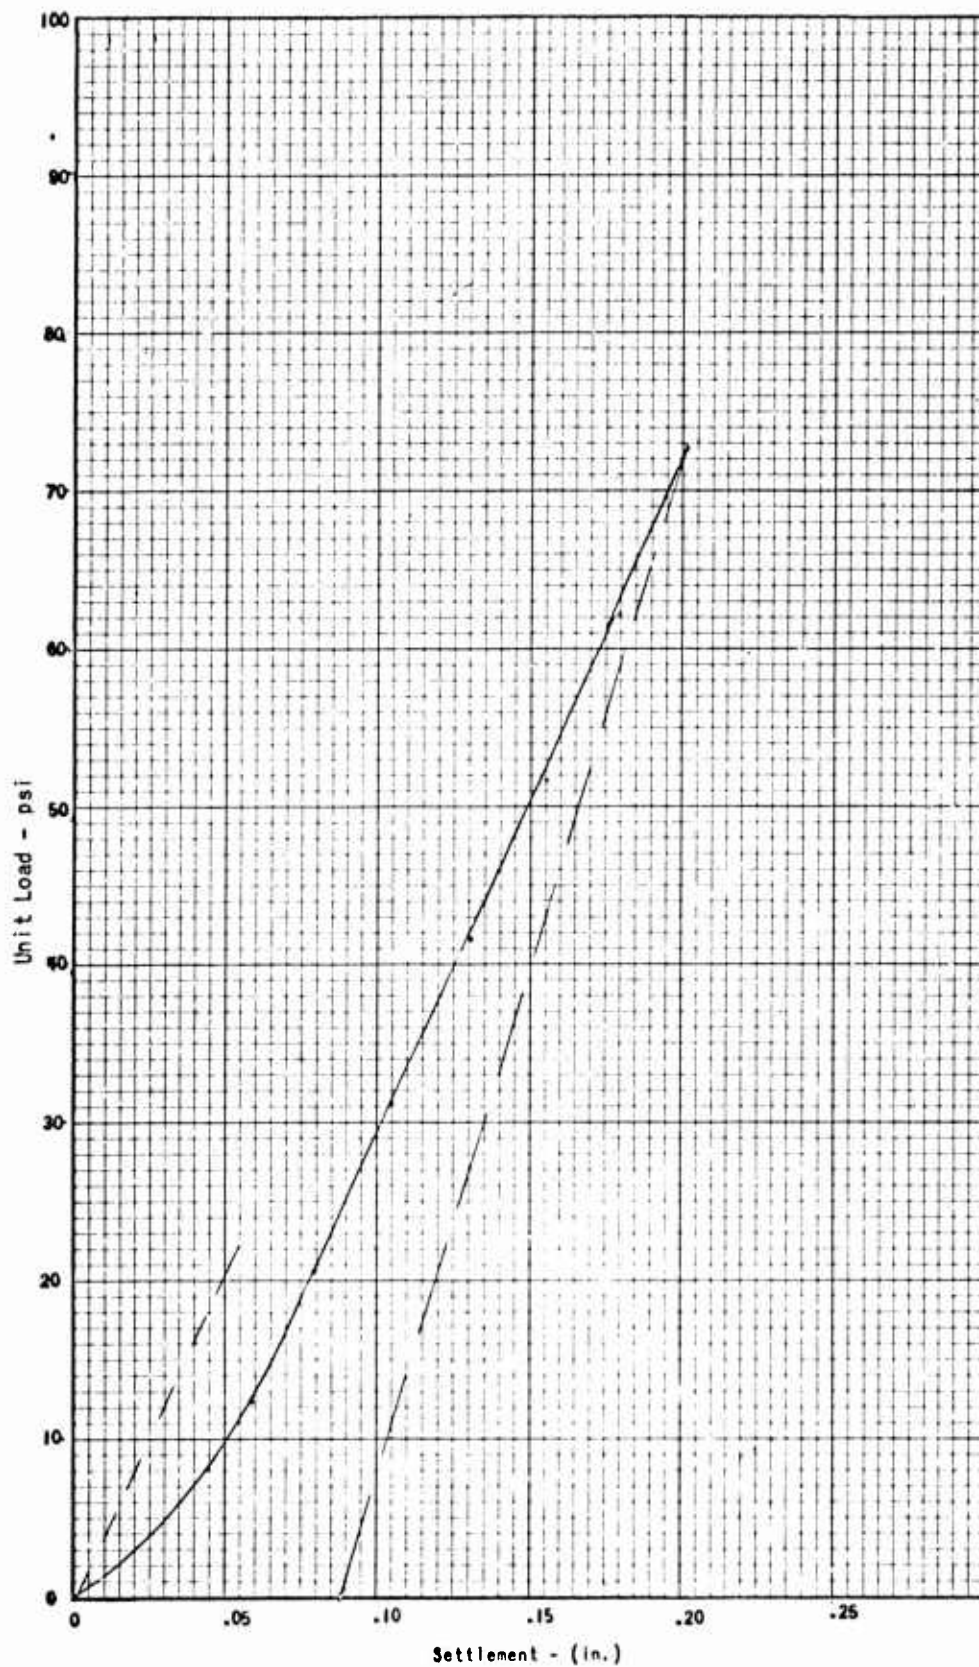
FACILITY	LOCATION	STATION
USMAF China Lake, California	Parking Apron 1	C

10" below top of  
portland cement  
concrete

E = 404 psi
